Elettra Sincrotrone Trieste

Present Status of Elettra RF Systems

M. Bocciai, V. Ingravallo, C. Pasotti, M. Rinaldi

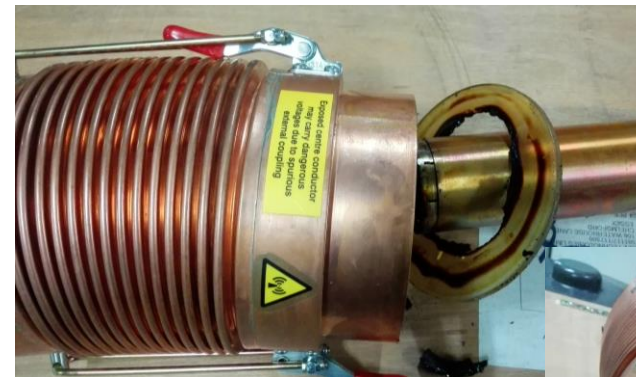
Homemade insulator to replace the damaged one

Inspecting a Klystron output line after a RF power level reading mismatch (no beam loss)
The original insulator is damaged and has to be replaced

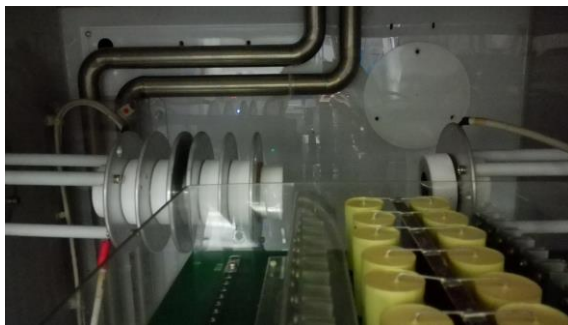
Both the HV power supply units expressed severe faults during the runs, in internal stages or in bleeding resistance.

HV multiplier (front) with damaged capacitors and broken bleeding resistance (back)

The availability of a spare HV power supply has guaranteed no dramatic impact on User Up-Time,

running one IOT at 68 kW for more than 470 hours (>2 weeks) continuously...

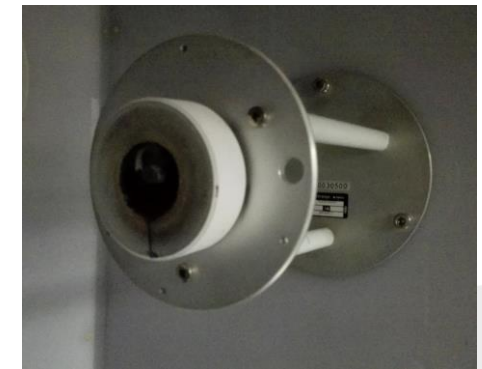
Broken bleeding resistance in detail

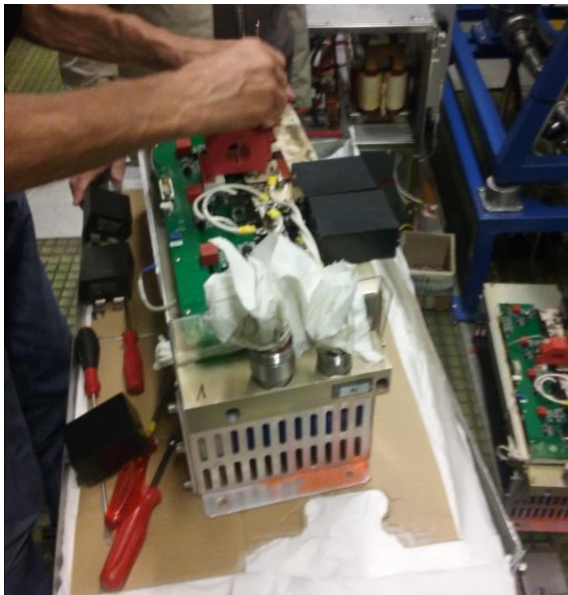
HV inverter module with broken current sensor and cooling liquid flooding

Though not directly related to RF operations, and luckily not generating consequences on IOTs, the faults on the HV power supply units were really challenging, and repair operations involved technicians from the transmitter manufacturer.

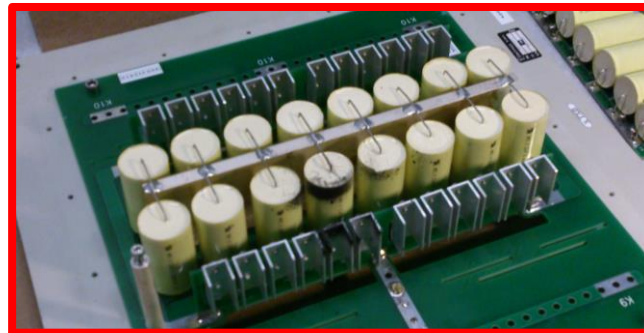
Performing a test on a repaired HV power supply feeding up to 36 kV

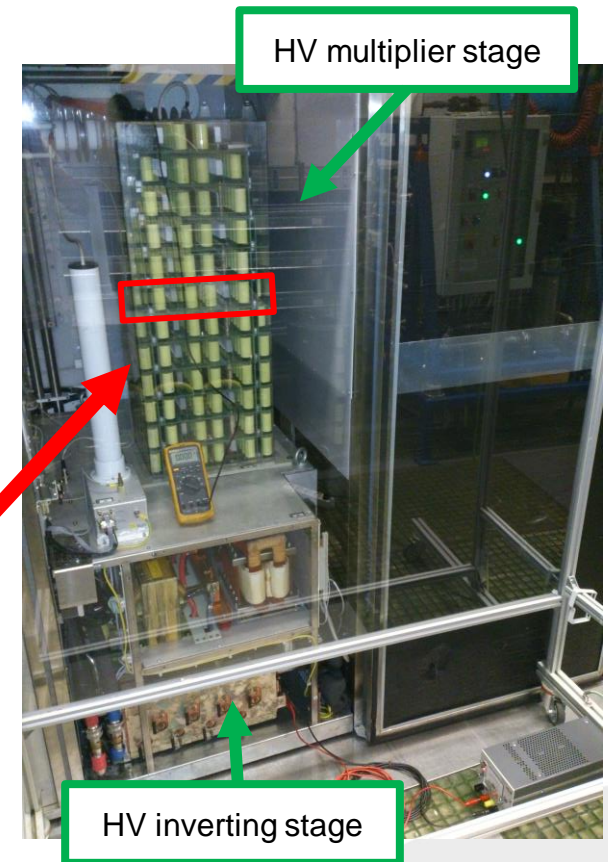
Damaged capacitors in HV multiplier bank
