News of 500 MHz rf activities at DESY.

Overview of different works during PETRA III shutdown

Stefan Wilke, DESY MHF-e
18th ESLS RF workshop
Dortmund, 2014-09-17/18

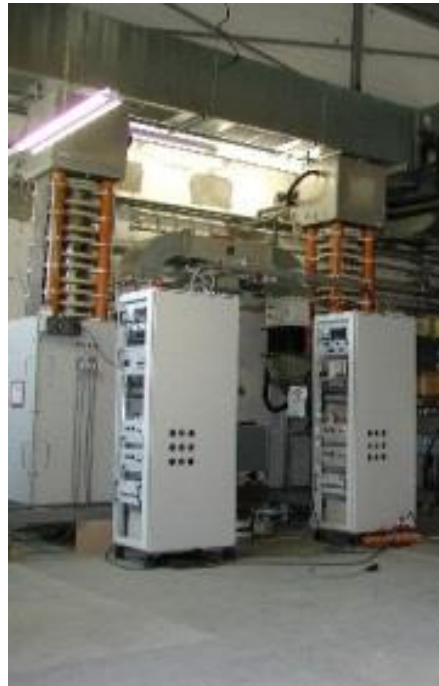
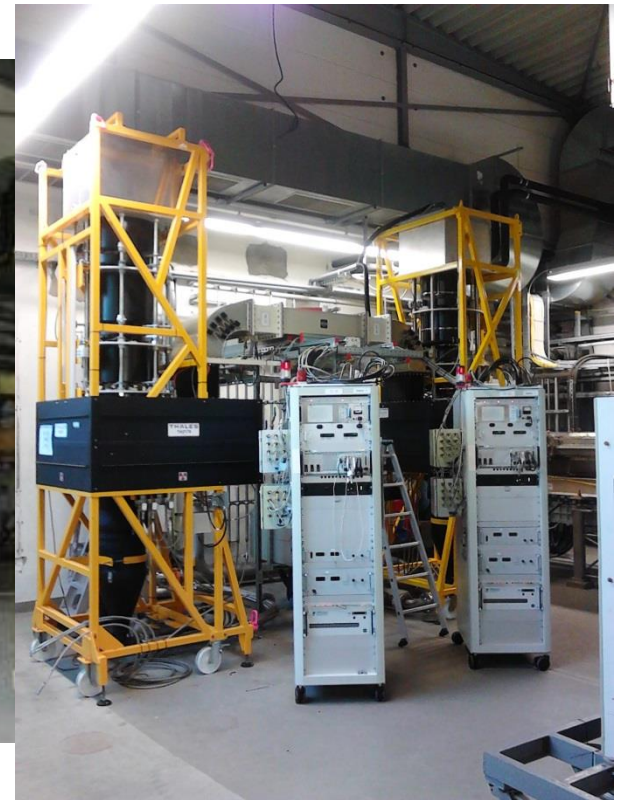
klystrons at PETRA.

- exchange of 2 philips klystrons (YK1304) by 2 from thales (TH-2178) in PETRA transmitter hall south left
- one with bad vacuum at the beginning
- they were installed at DORIS
- until now more than 300kW each

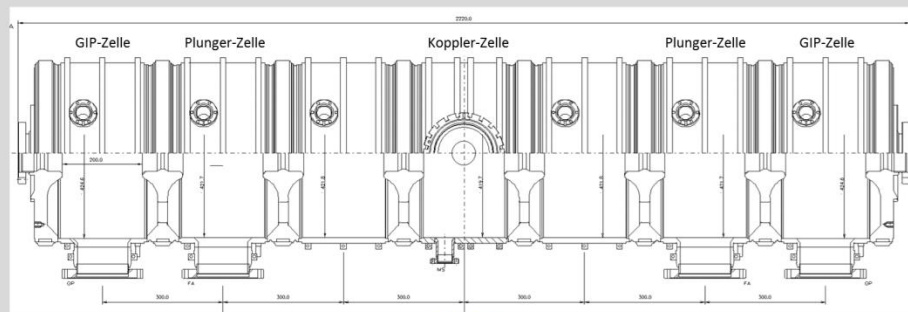
fields in cavities with seldom trips

- upgrade the cavity water temperature regulation to set plungers more in
- it seems that cavities with plungers more in did not trip so often

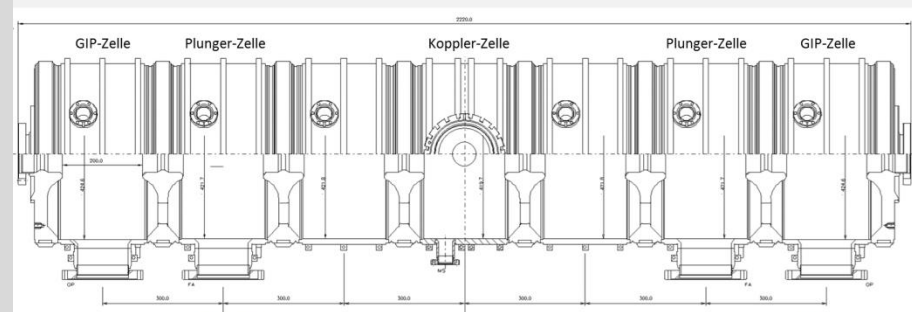
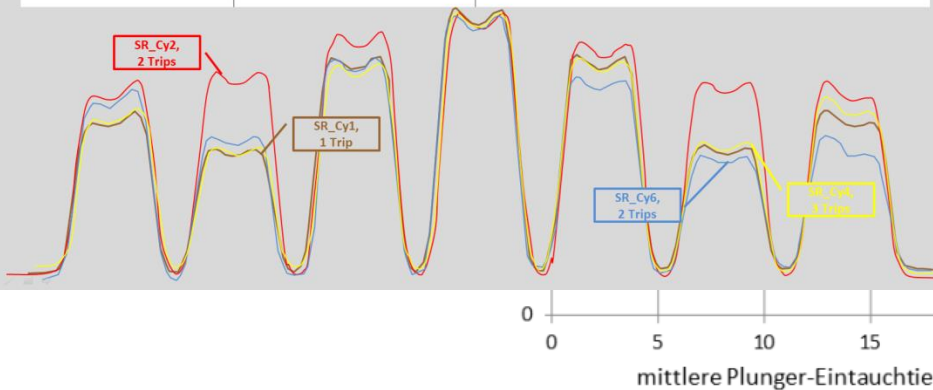
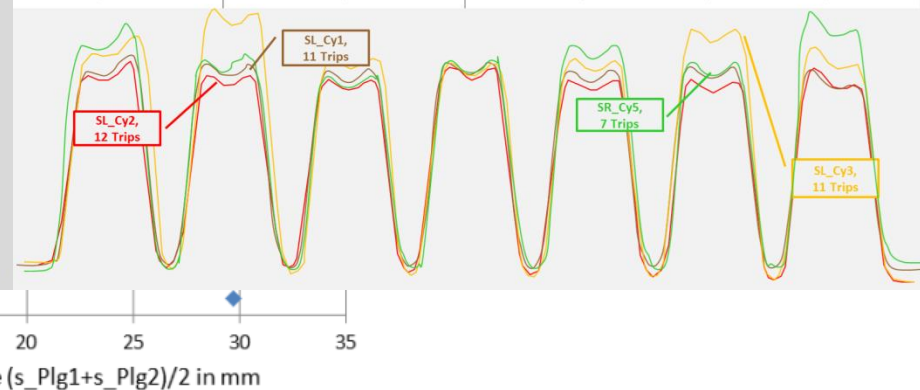
fields in cavities with often trips

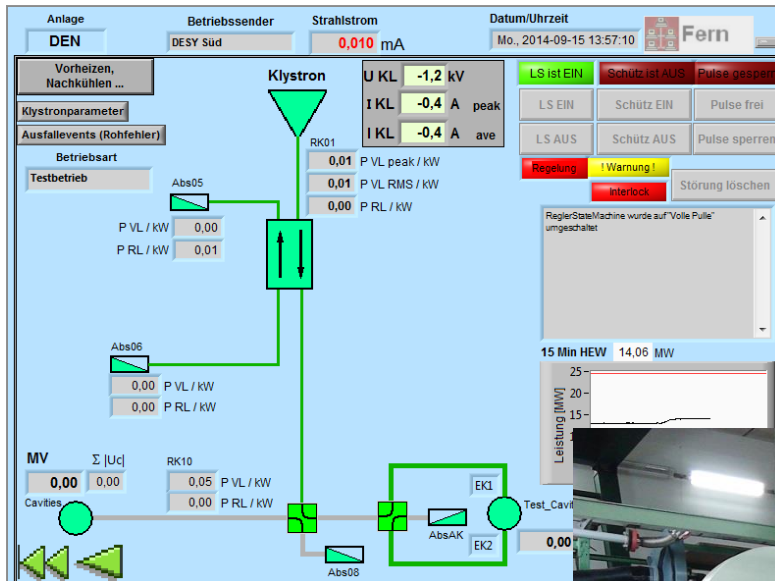
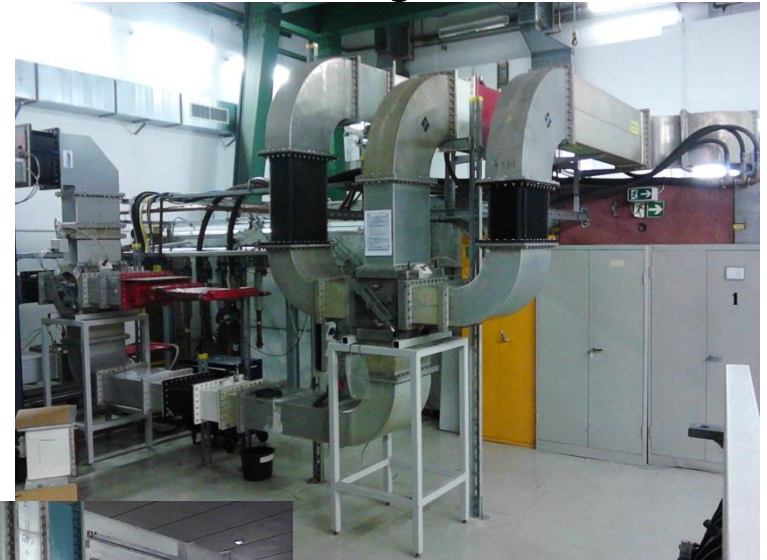
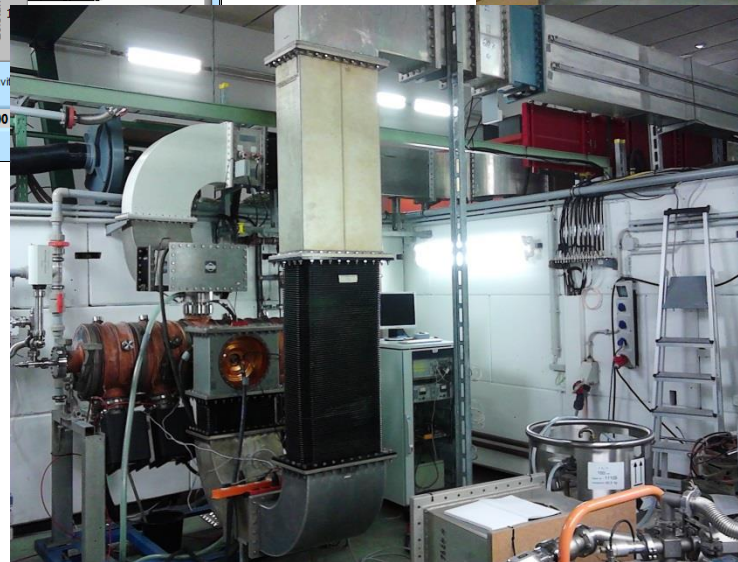
cavity teststand.

- cavity teststand to investigate „blue light“ and conditioning a set of spare couplers (2 couplers, one venting)

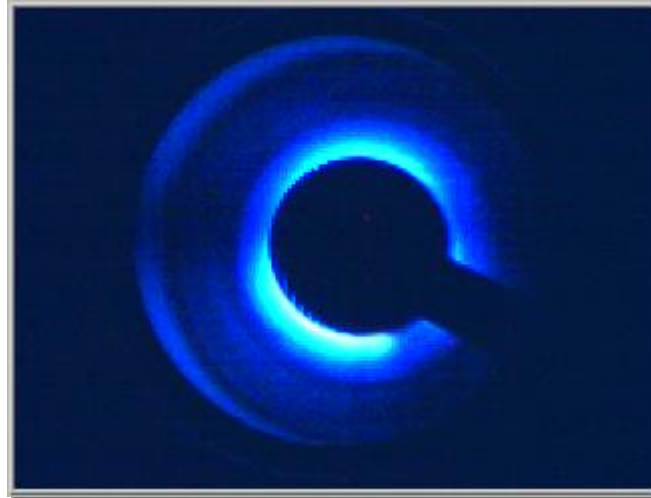
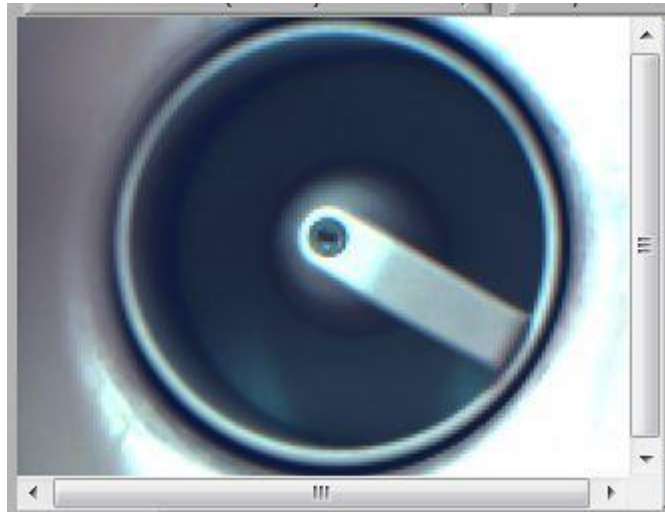
blue light.

- short sequence at ca. 100 kW
- test are made with AM and FM (50 kHz)

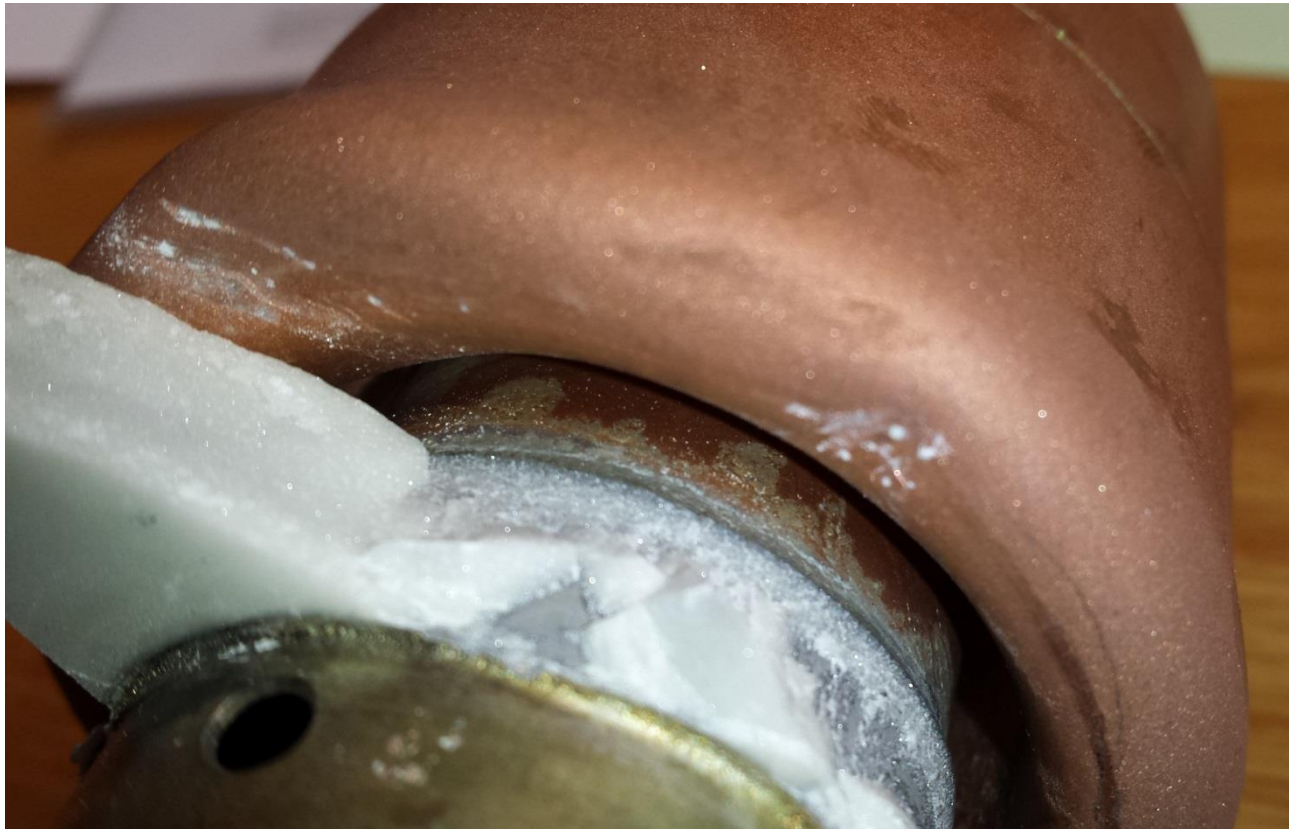
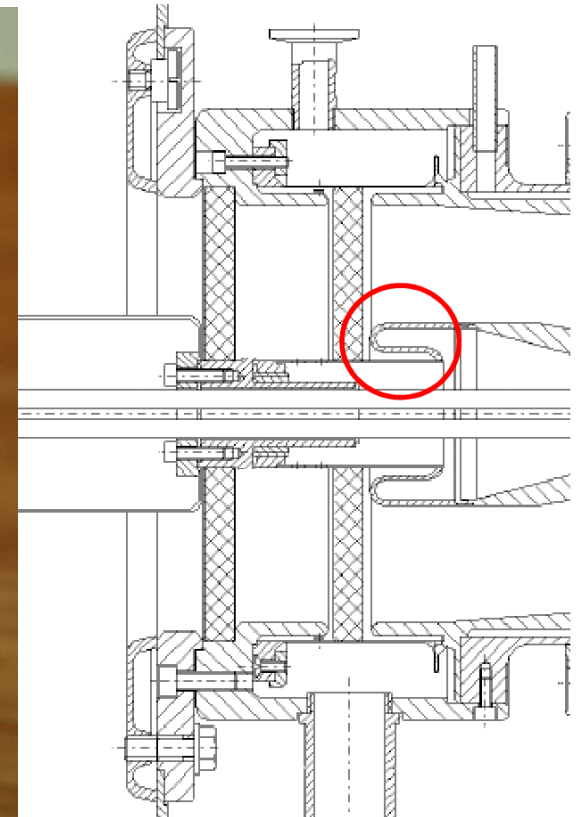
coupler inspection.

- coupler with manually broken ceramik (vacuum side) to inspect the suspicious area (silver solder)

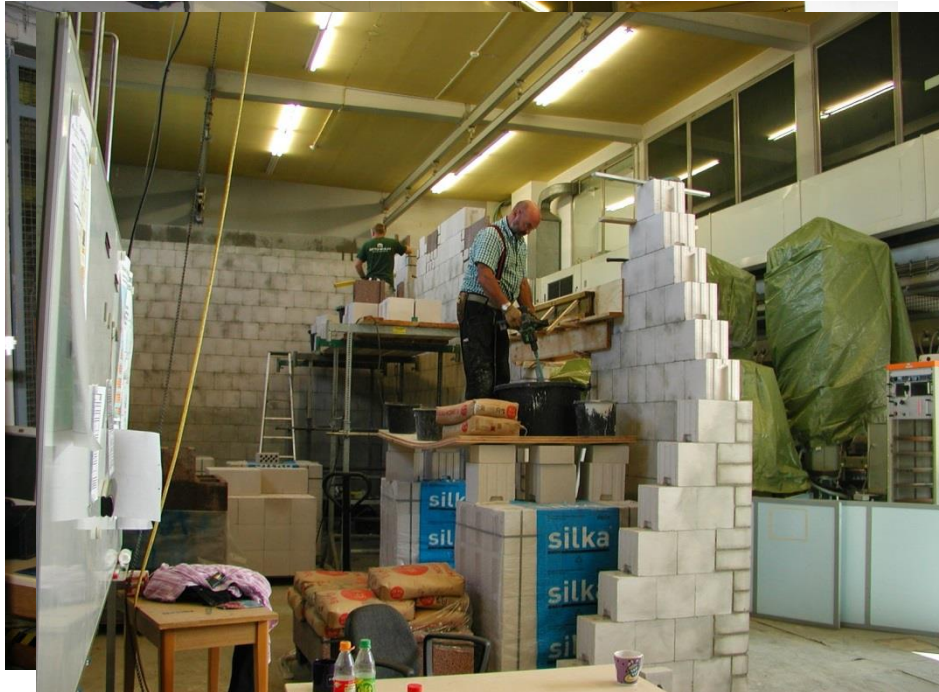
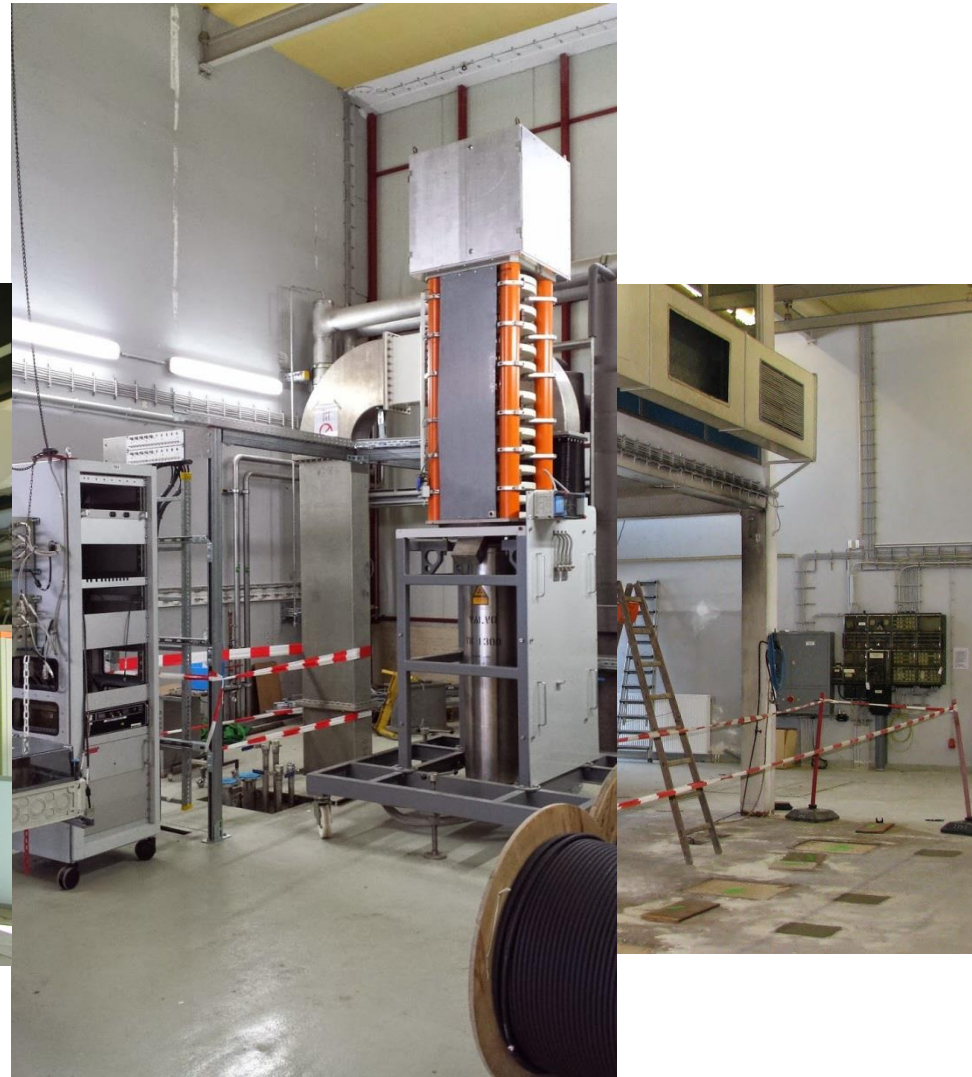
transmitter DESY south.

- new klystron: thomson → philips
- new controls: PLC → ZWERG
- new rooms

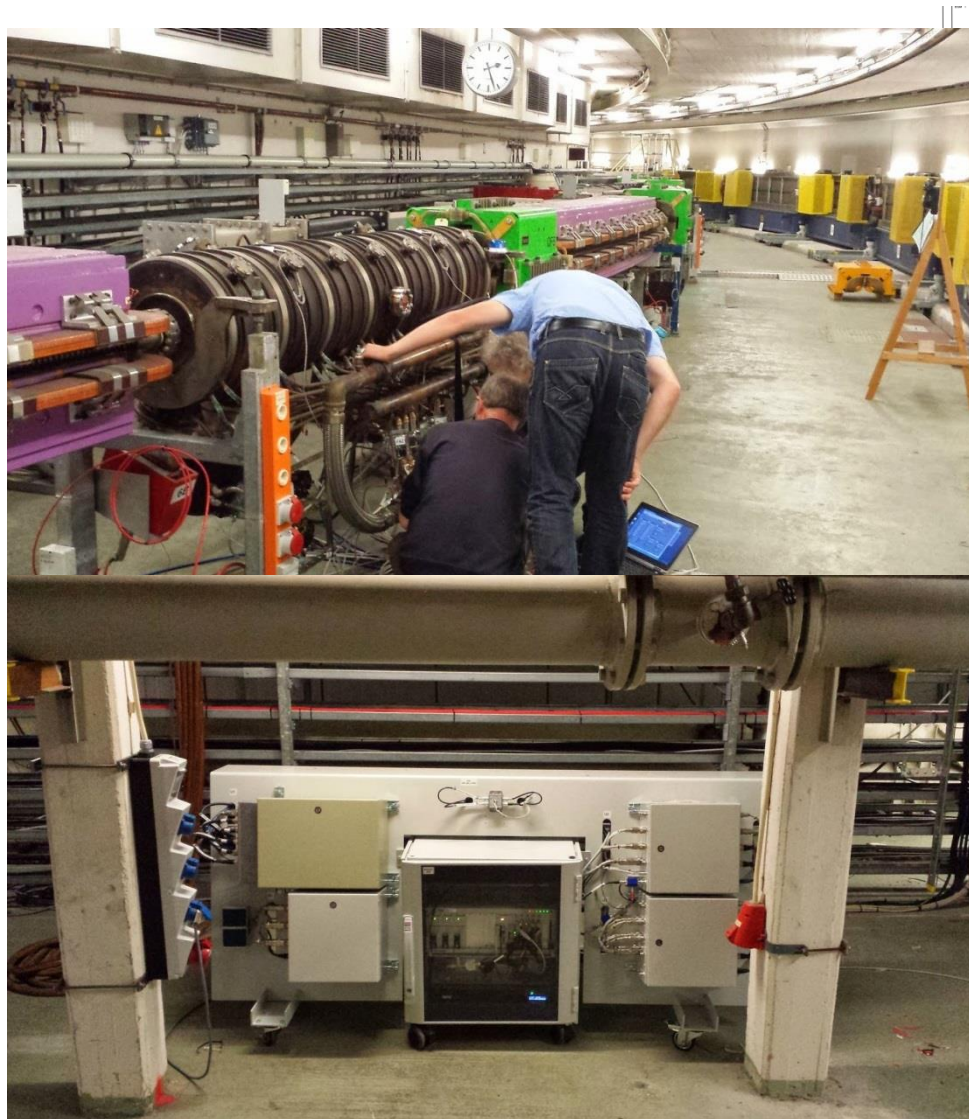
radiation at positions of electronic.

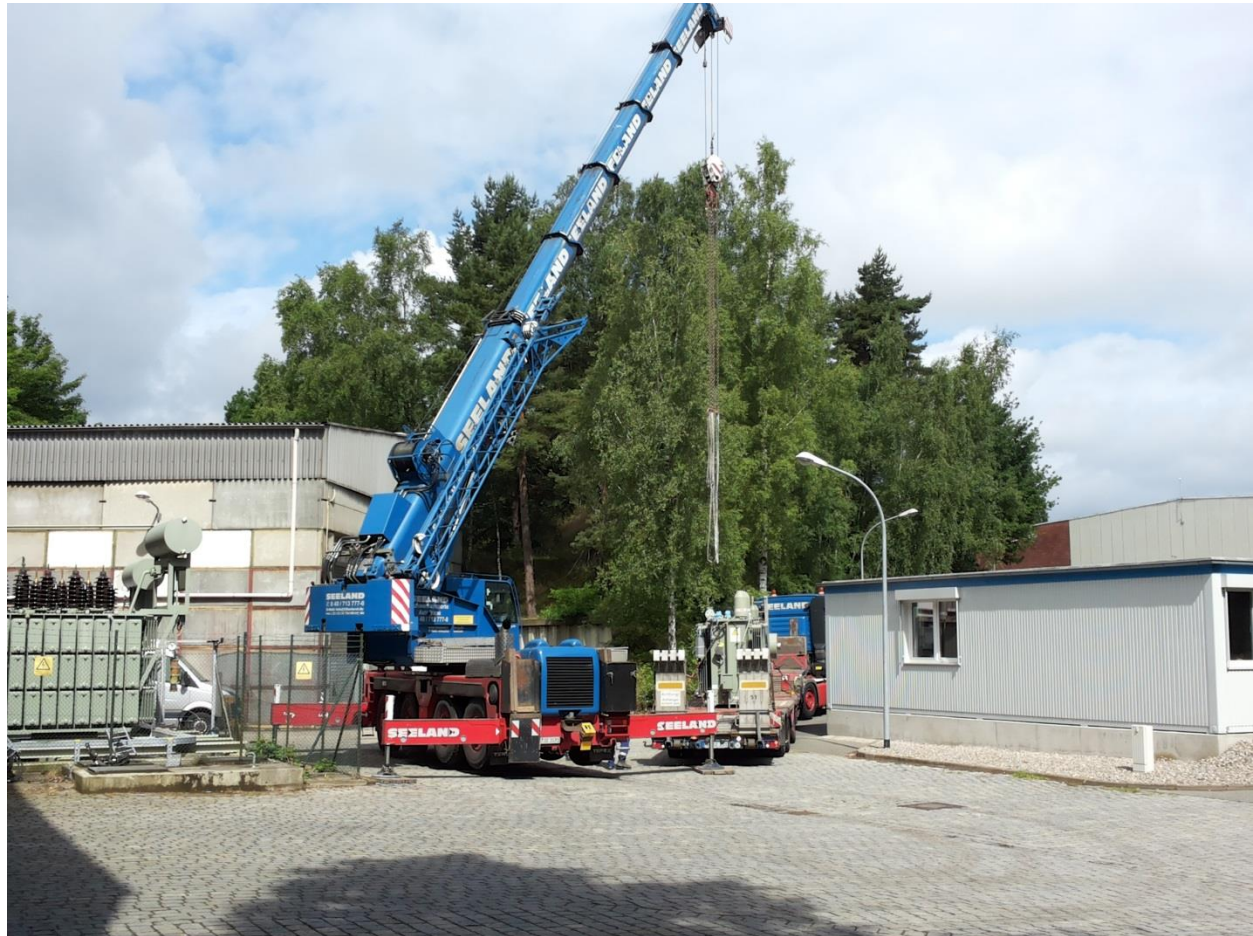
reconditioning transformers.

- our HV group send the old transformers of our DESY transmitters to reconditioning

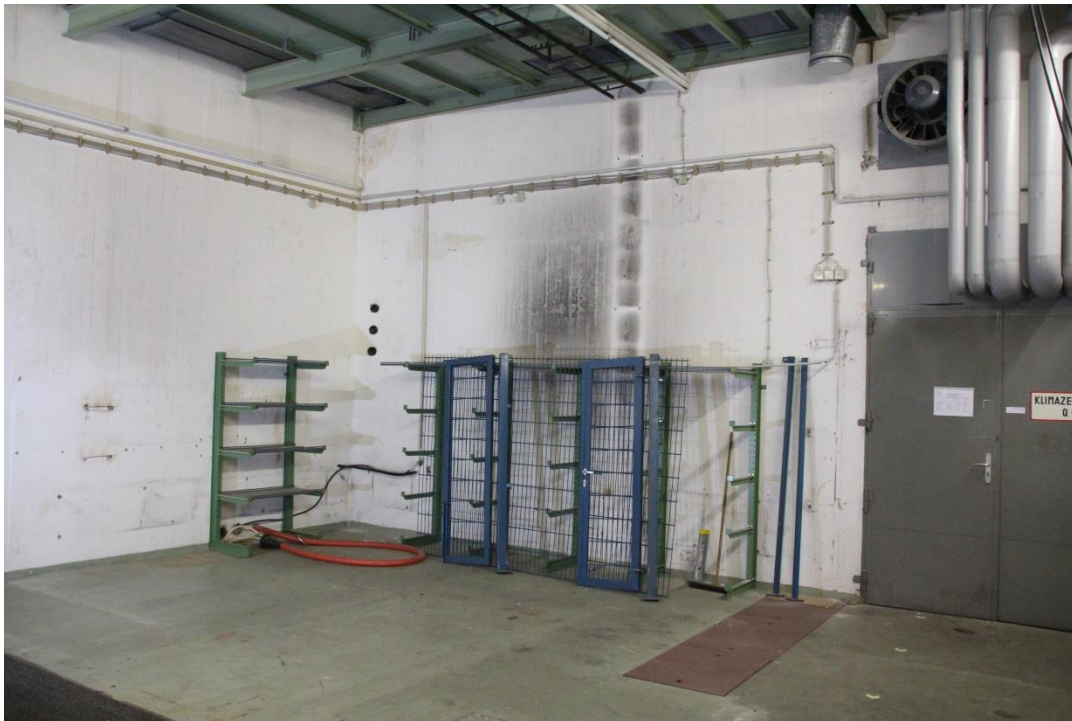
future cavity tests.

- we start work to use one of the switched-off DORIS transmitter for future cavity tests
- so the now used transmitter DESY north can run for operation

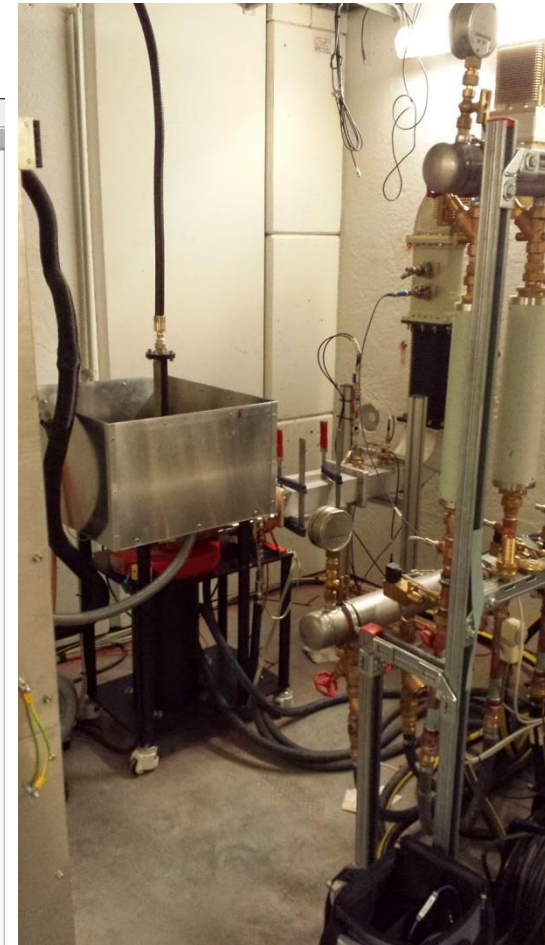
verificationtest of 2. prototype IOT from CPI.

- 1.3 GHz, 100 kW cw reached, drive 422 W, gain 23.7 dB
- less power when pulsed
