# First Experience with DELTA's upgraded RF

P. Hartmann  
DELTA, TU Dortmund

# DELTA's 500 MHz RF systems

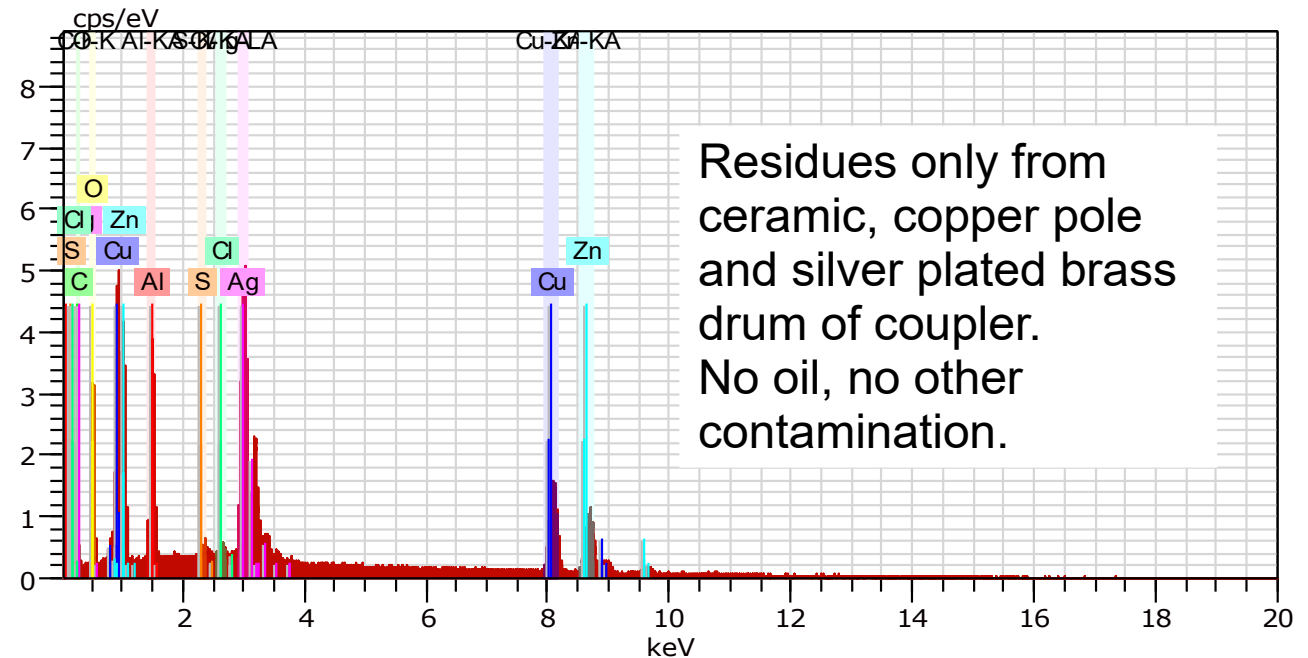
# Broken power coupler

The cause for the arcing was presumably a particle from the 1m long rubber air hose between the particle filter and the coupler. This kind of particles were found in the air filter.

Remedies:

- Replaced rubber hose with hose having a smoother surface on the inside.
- Installed fast reflected power interlock.

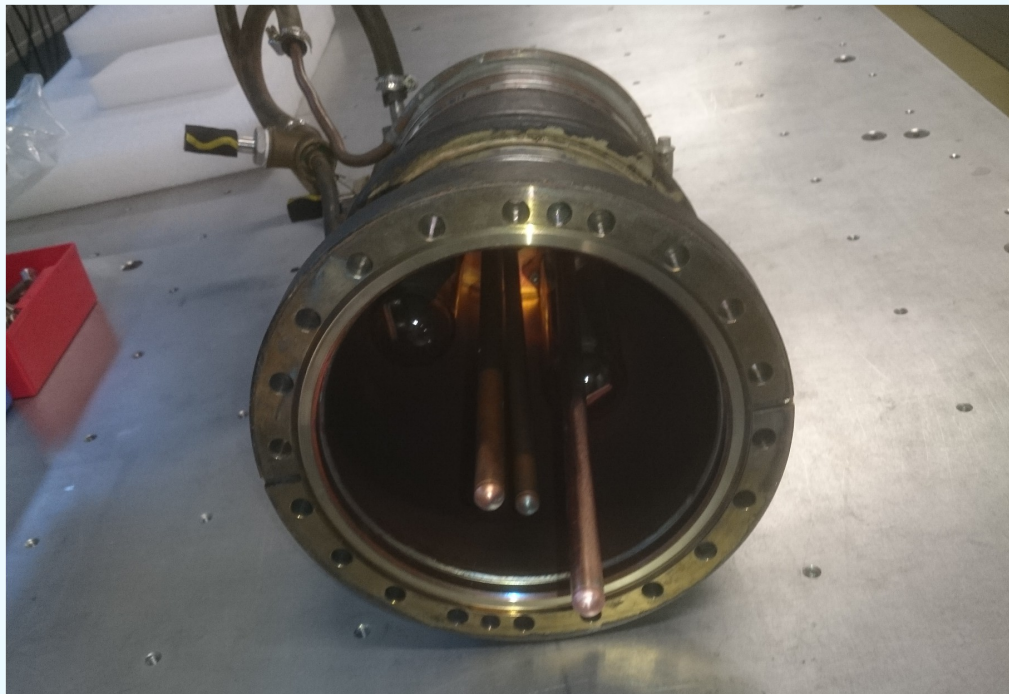
# Leaking HOM damper (DORIS)

Incident: Vacuum pressure increase in RF area.

No leak found with He leak search.

No leak found with He immediately after blowing water out of the cooling tubes.

**Leak found after blowing air through the water tubes for ~2 hours**

→ Sudden vacuum pressure increase by 2 orders of magnitude.

Apr. 2019: Water leak on HOM damper (DORIS)  
→ removed HOM damper

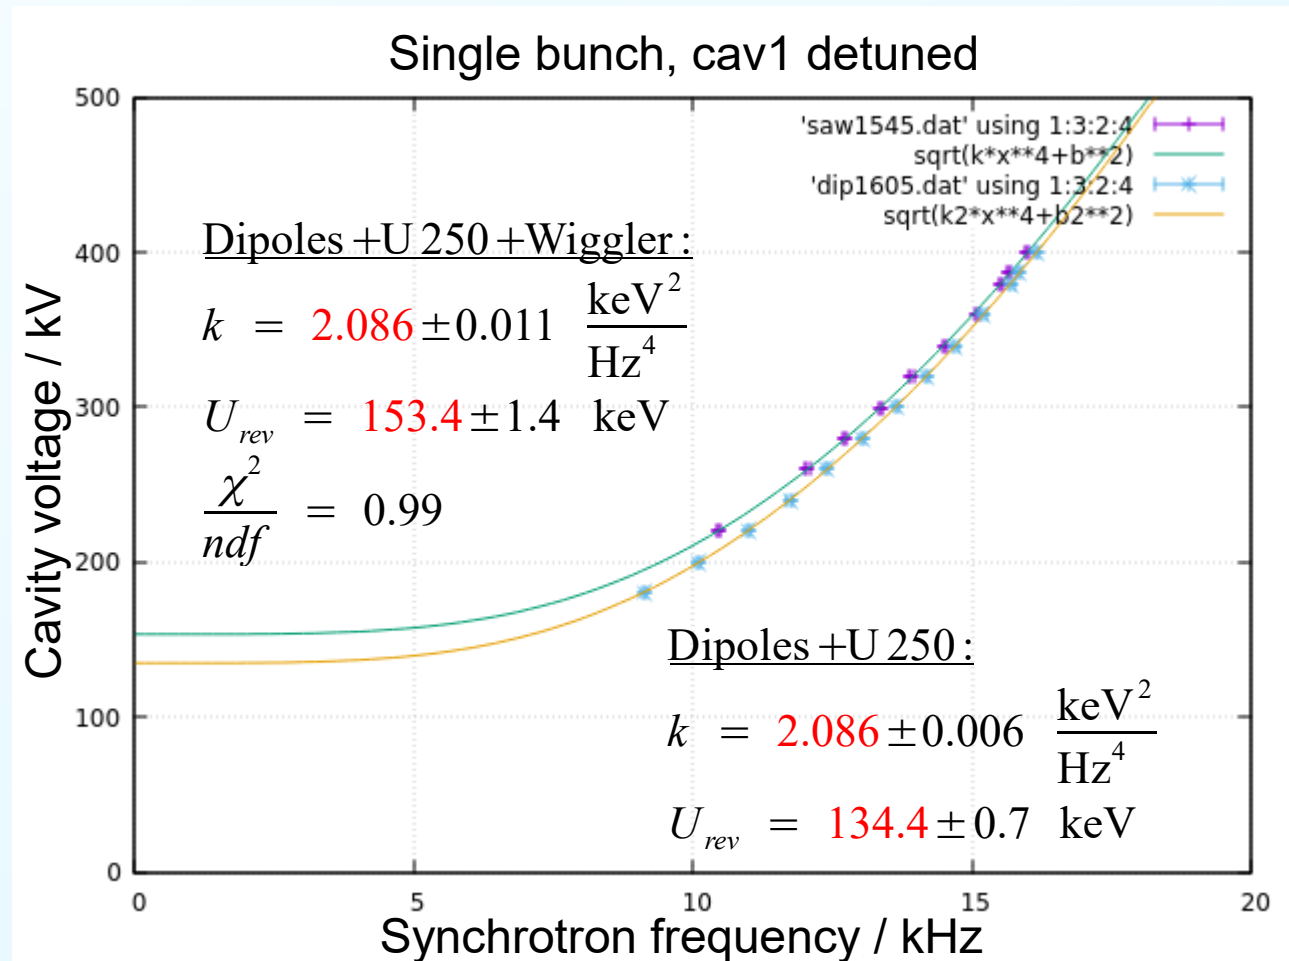
# LLRF calibration check with beam

$$\text{Synchrotron frequency: } f_s = f_{rev} \sqrt{\frac{\alpha h e U_C}{2\pi E} \sin(\phi_S)} \quad , \quad \sin(\phi_S) = \sqrt{1 - \left(\frac{U_{rev}}{U_C}\right)^2}$$

$$U_C = \sqrt{\underbrace{\left(\frac{2\pi E}{f_{rev} \alpha h e}\right)^2 f_s^4}_{k} + U_{rev}^2}$$

$$\rightarrow k^{calc} = 2.076 \frac{\text{keV}^2}{\text{Hz}^4}$$

$$U_{rev}^{Dipoles+U250+Wiggler} = 150 \text{ keV}$$

$$U_{rev}^{Dipoles+U250} = 128 \text{ keV}$$
