Elettra Sincrotrone Trieste

Present Status of Elettra RF Systems

M. Bocciai, V. Ingravallo, C. Pasotti, M. Rinaldi

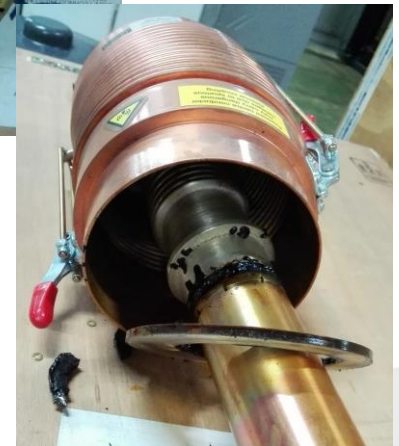
Aging is a huge factor for long running facilities as Synchrotrons

Inspecting a Klystron output line after a RF power level reading mismatch (no beam loss)
The original insulator is damaged and has to be replaced

Homemade insulator to replace the damaged one
